Intel® Celeron® D Processor 300^Δ Sequence

Specification Update

– On 65 nm Process in the 775-land LGA Package

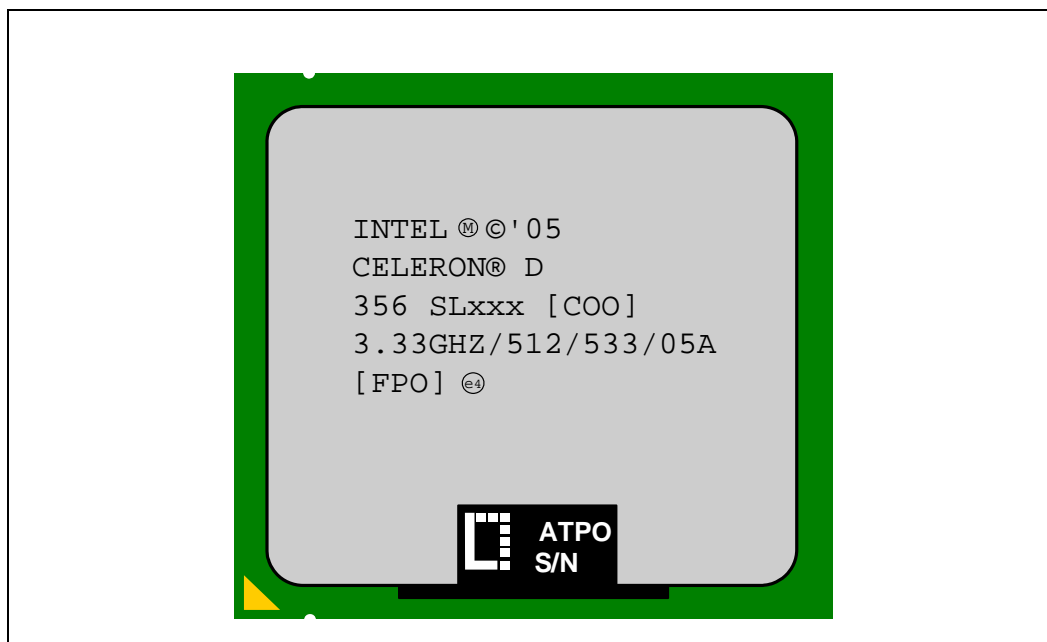
Figure 1. Intel® Celeron® D Processor 300 sequence Package supporting 775_VR_CONFIG_05A Specifications (Top Markings for C1 stepping)

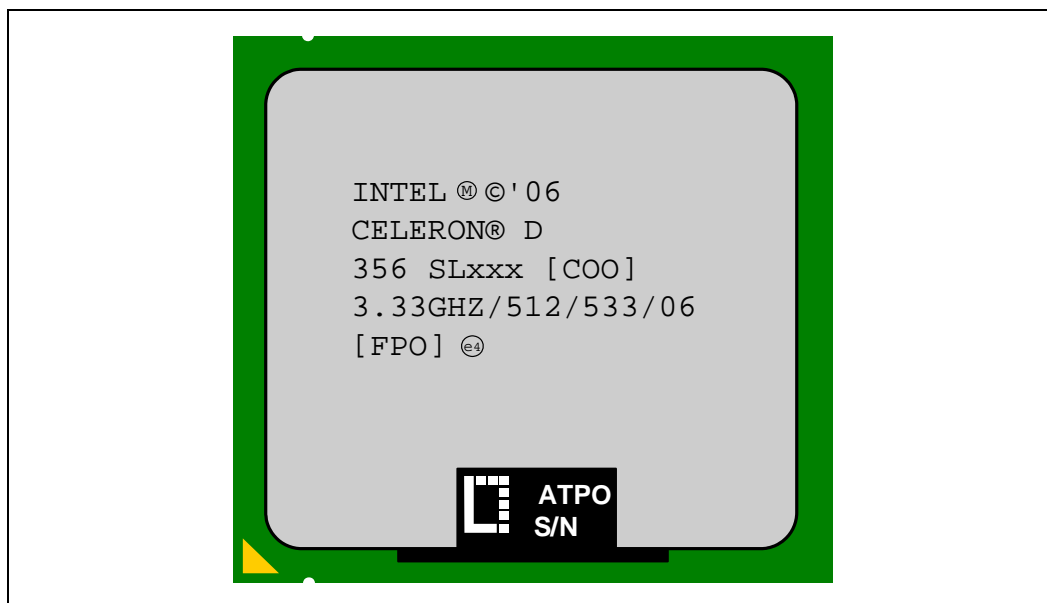
Figure 2. Intel® Celeron® D Processor 300 sequence Package supporting 775_VR_CONFIG_06 Specifications (Top Markings for D0 stepping)
